Desktop review – Impact of bushfires on water quality

For the Australian Government Department of Sustainability, Environment, Water,
Population and Communities

18th March 2011

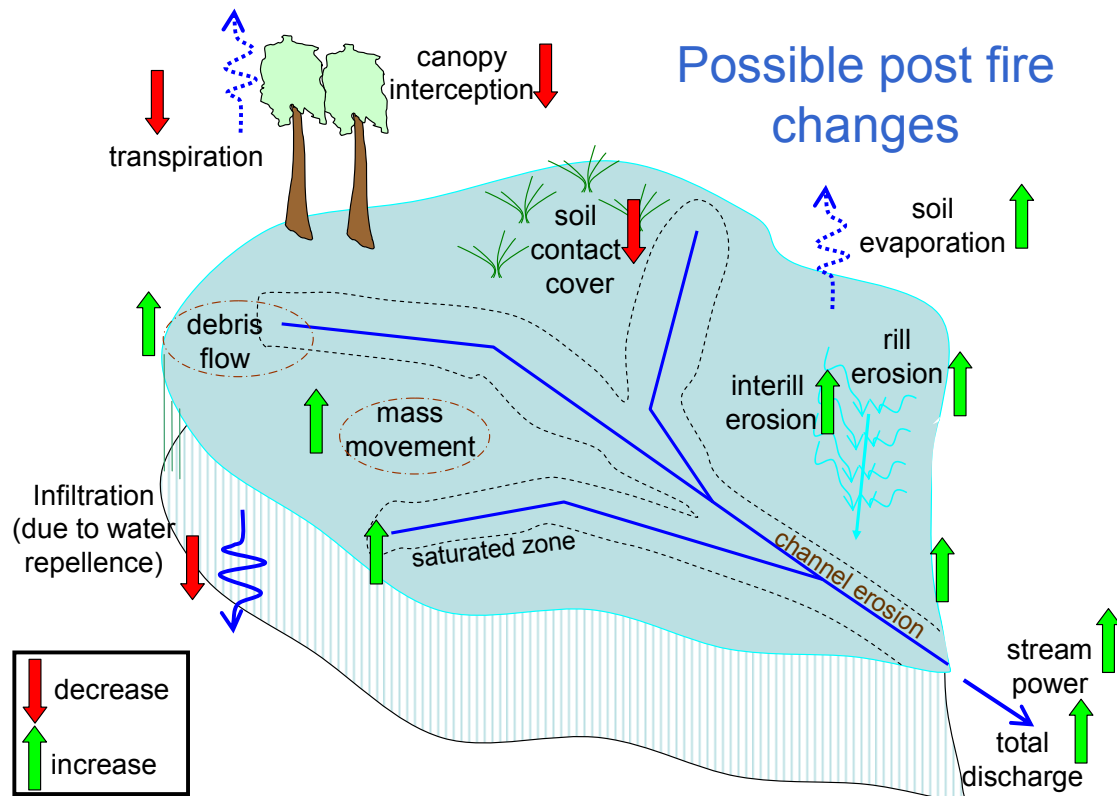
Figure 1: Schematic diagram showing possible post-fire changes in hydrologic and erosion processes.

A number of processes can cause water quality impacts following fire. In this section, we briefly review these processes and the key factors influencing them (Figure 1).

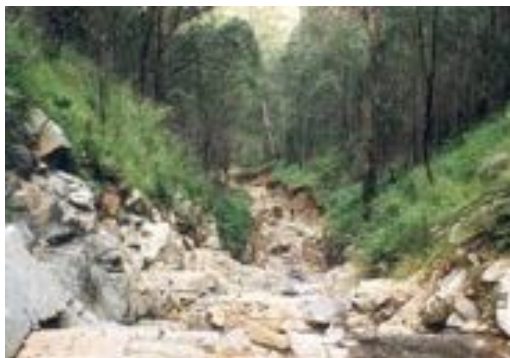
Figure 2: Channel scoured by a post-fire debris flow in a tributary of the Upper Buckland River, Victoria, which was burned in 2003. (Photo: Gary Sheridan).

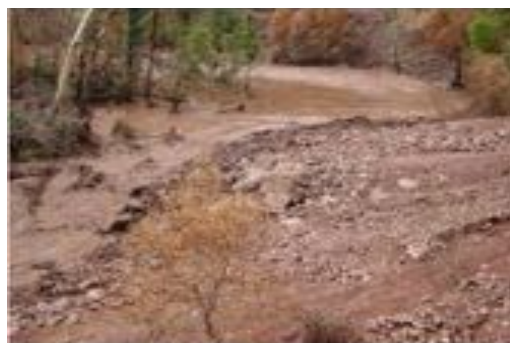
Figure 3: Flow downstream of a post-fire debris flow in the Wellington River (above the junction with the Macalister River). (Photo: Adrian Murphy, Melbourne Water).

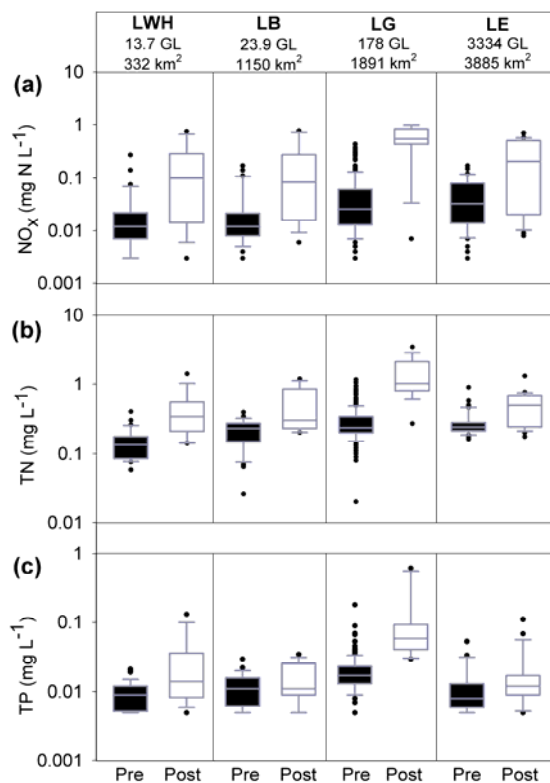
Figure 5: Box plots of pre and post-fire two-four weekly measurements of a) NO_x, b) TN and c) TP in four reservoirs (LWH: Lake William Hovell; LB: Lake Buffalo; LG: Lake Glenmaggie; LE: Lake Eildon) with catchments burnt by bushfire in 2006-07 in Victoria, south-eastern Australia. Box plots display the 10th, 25th, median, 75th, 90th percentiles and outliers. Data supplied by the Goulburn-Murray Water Authority and the Victoria Water Resources Data Warehouse.

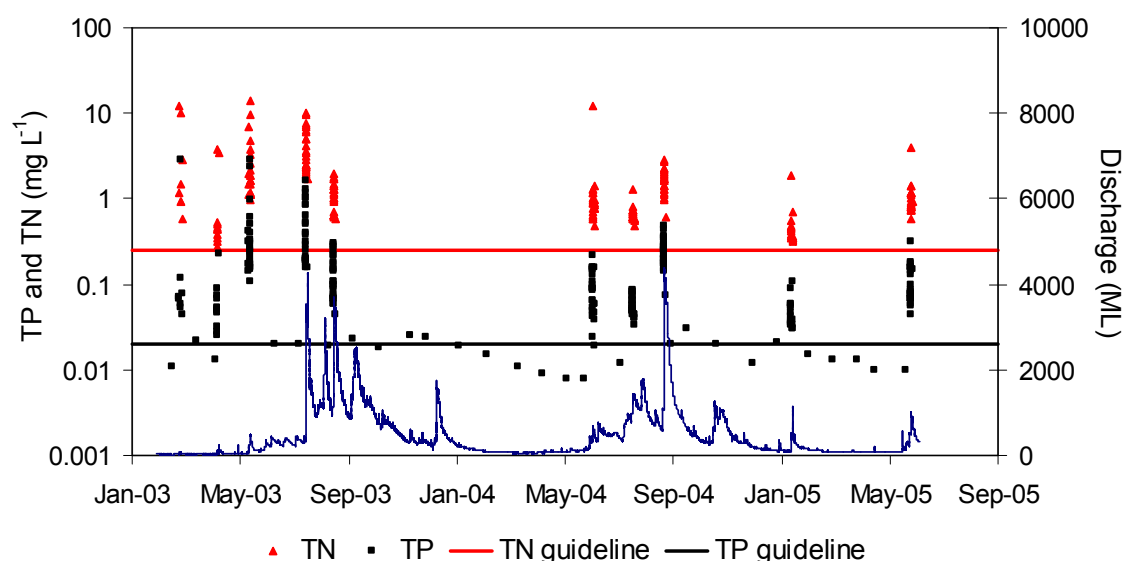
Figure 8: Comparing guideline values to total nitrogen and total phosphorus concentrations for the Ovens River at Bright (north-east Victoria) following the 2003 bushfires (data provided by North East Water).

- in the Ovens River at Bright, upstream of the impact of post-fire debris flows, post-2003 fire maximum TN concentrations were 56 times the guideline value and TP concentrations were 145 times the guideline value. During the subsequent 2.5 years, TN and TP concentrations in the Ovens River at Bright exceeded the guideline values during all automatically sampled flow events (Figure 8), and
